FULLER'S LAKE DAM

NDI No. PA 00073
PennDER No. 58-121
Dam Owner: Frederick Hoal

PHASE I INSPECTION REPORT NATIONAL DAM INSPECTION PROGRAM

February 1981

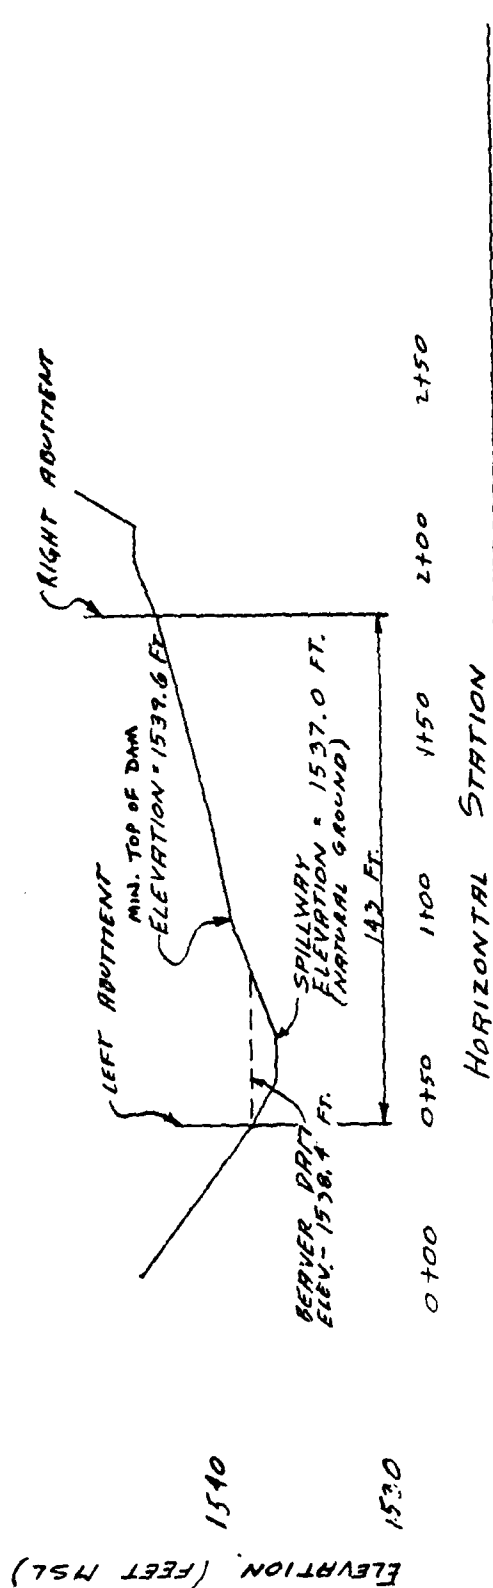
TOP OF DAM PROFILE (LOOKING DOWNSTREAM):

- b. Dam - Clear seepage was observed exiting the downstream slope at a rate of approximately 7.5 g.p.m. The vegetation and the erosion channel away from the seep indicated that the seepage has been occurring for a long period of time. The seep is located 8 feet vertically below the crest of the dam, at station 1+40 (see Field Sketch in Appendix A).
